NASA/TM-2003-212439  
ARL-TR-3046

# Characterization of Cracking and Crack Growth Properties of the C5A Aircraft Tie-Box Forging

*Detailed destructive examinations were conducted to characterize the integrity and material properties of two aluminum alloy (7075-T6) horizontal stabilizer tie box forgings removed from U.S. Air Force C5A and C5B transport aircraft. The C5B tie box forging was found to contain no evidence of cracking. Thirteen cracks were found in the C5A forging. All but one of the cracks observed in the C5A component were located along the top cap region (one crack was located in the bottom cap region). The cracks in the C5A component initiated at fastener holes and propagated along a highly tunneled intergranular crack path. The tunneled crack growth configuration is a likely result of surface compressive stress produced during peening of the forging surface. The tie box forging fatigue crack growth, fracture and stress corrosion cracking (SCC) properties were characterized. Reported herein are the results of laboratory air fatigue crack growth tests and 95% relative humidity SCC tests conducted using specimens machined from the C5A forging. SCC test results reveal

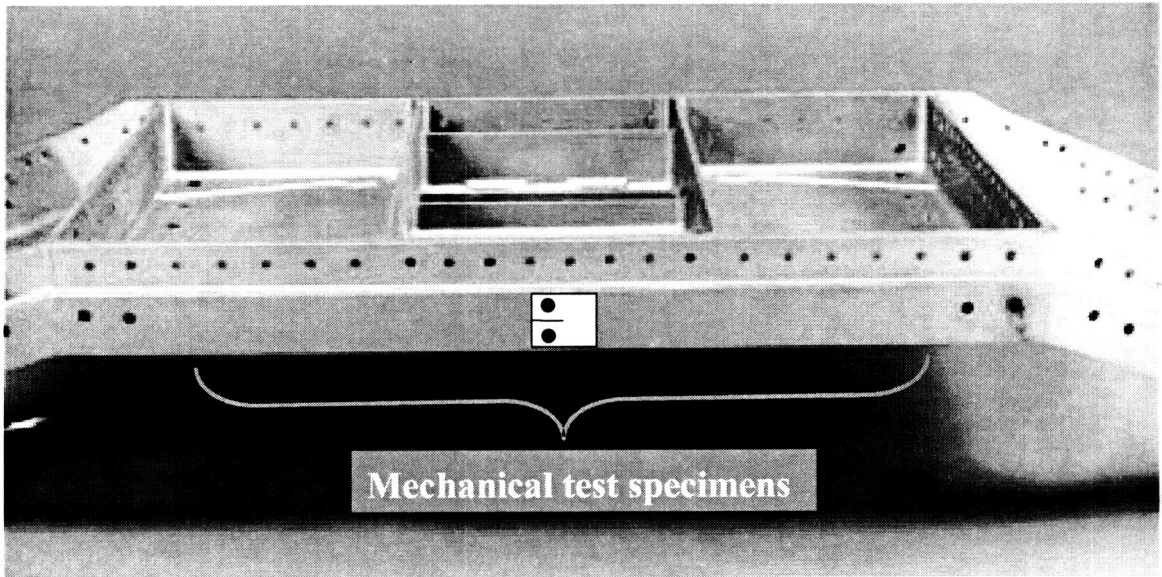
Figure 2. The photograph shows the C5A forging top cap center region. Fracture toughness and stress corrosion specimens were machined from the cap region for the C5A and C5B forging.

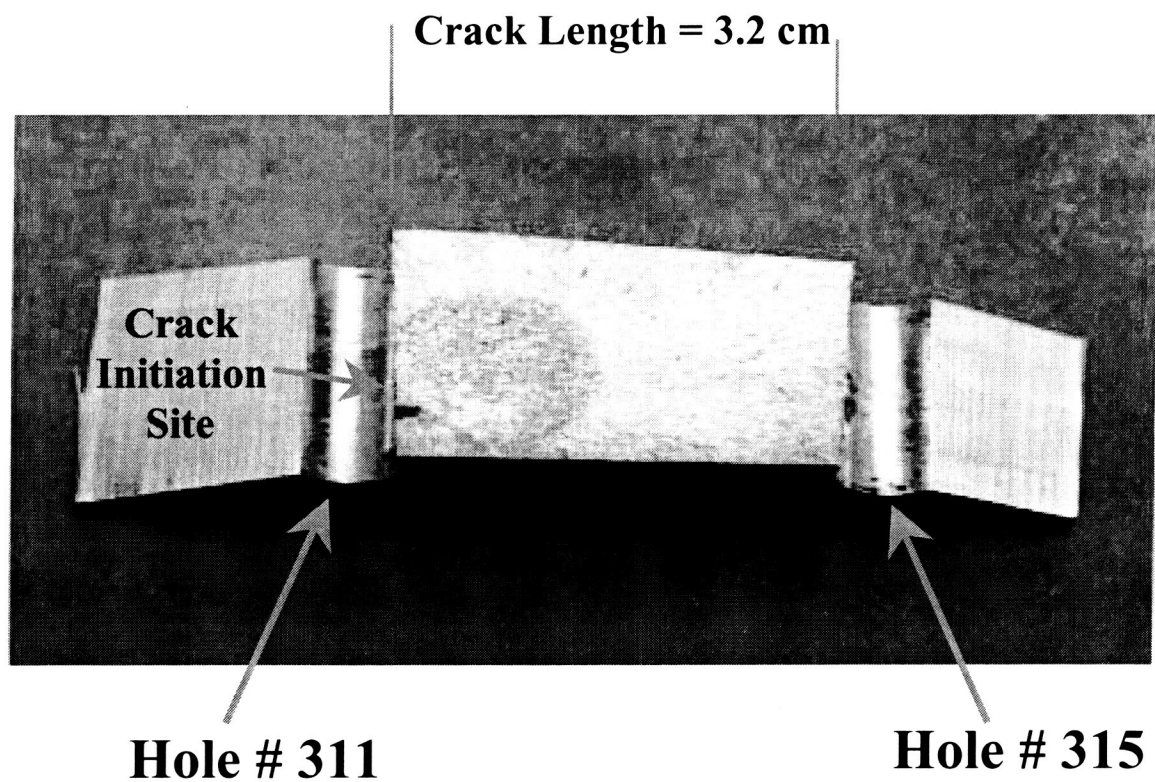
Figure 5. The photograph shows the surface of the crack emanating from hole #311 and propagating to hole #315.

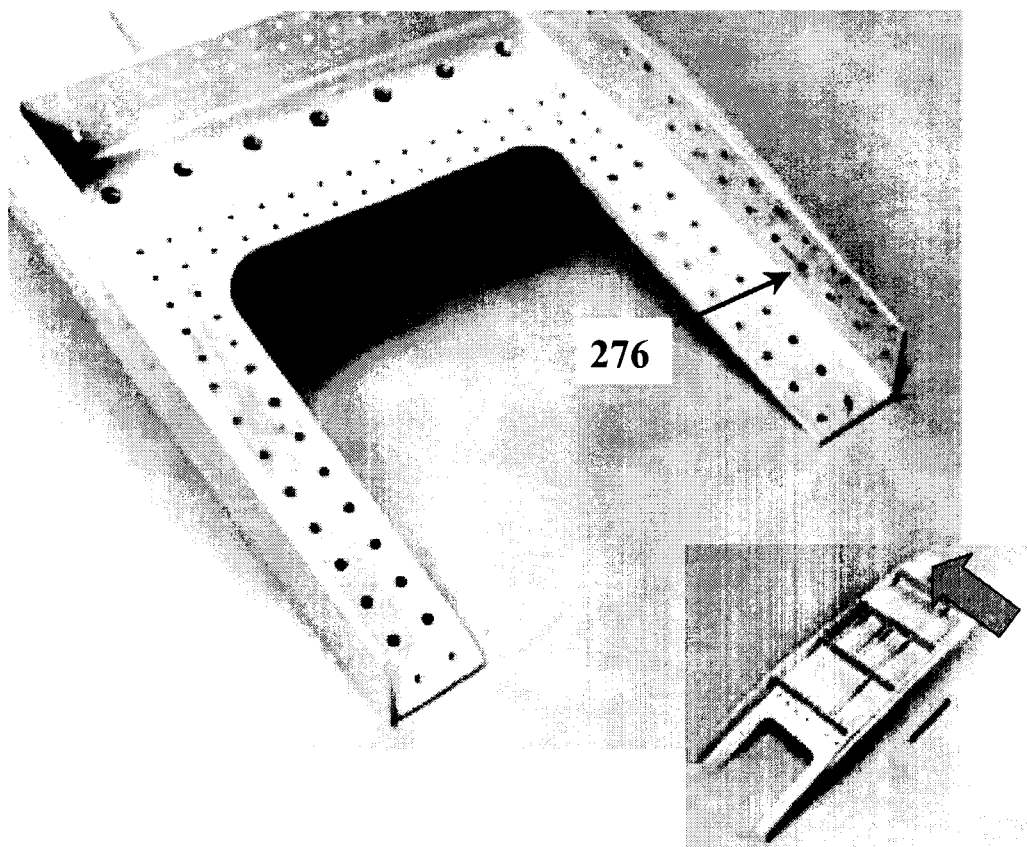
Figure 9 shows the location and orientation of the crack that initiated at fastener hole #276 in the tie-box lower cap arm. Figure 10 shows the surface of the crack; here, two halves (metallographic sections) of the specimen were placed together so the complete crack surface could be viewed. The crack initiated in the interior of fastener hole #276. The dashed line marks the curved crack front. The discolored regions on the crack surface are areas of heavy corrosion products. The crack initially propagated in a tunneled crack front configuration and first penetrated one surface (upper side surface in Figure 10) and later penetrated the other side surface thus forming the final curved crack front. Prior to opening the crack and examining the crack surface shown in Figure 10, a metallographic cross-section was performed normal to the crack to determine the microstructural crack path (this is the reason why two pieces are present in Figure 10). Figure 11a shows the location of the crack and the surrounding etched grain structure. Figures 11b and 11c show portions of the crack at higher magnification. Figure 11b shows that the cracking is intergranular and some regions exhibit extensive intergranular crack branching. Figure 11c shows the crack-tip region located on or very near a grain boundary.

Figure 9. The large photograph shows the inside surface of the lower cap arm region of the C5A tie-box (the region is identified by the arrow in the small photograph). The line identifies the location of the crack at fastener hole #276.

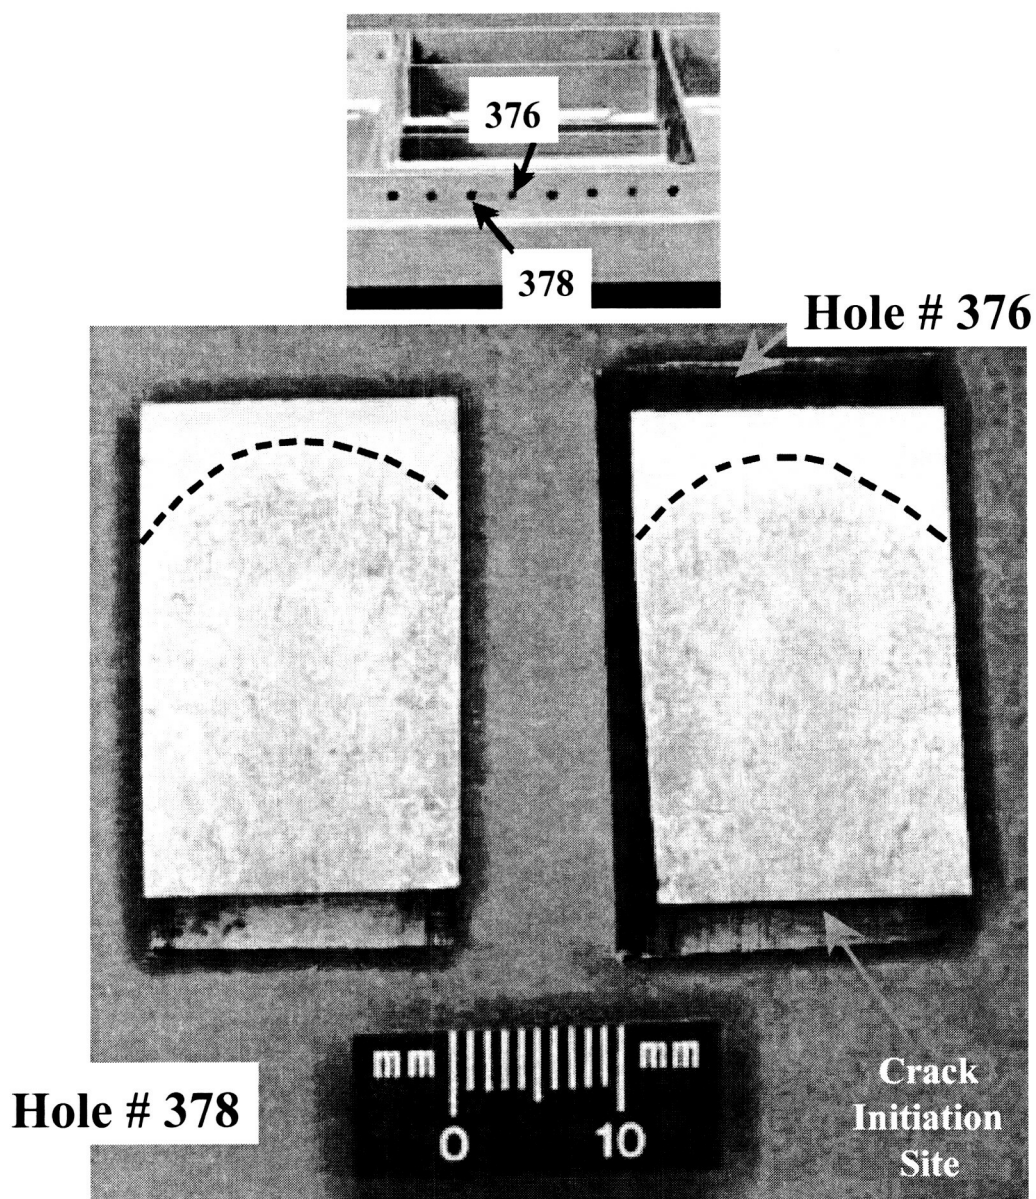
Figure 16. The photograph shows both surfaces of the crack emanating from fastener hole #378. The location of fastener holes #378 and #376 is shown in the small photograph.

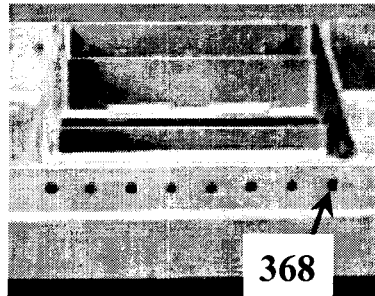
Figure 20. The photograph shows both surfaces of the crack emanating from fastener hole #368. The location of fastener hole #368 is shown in the small photograph.

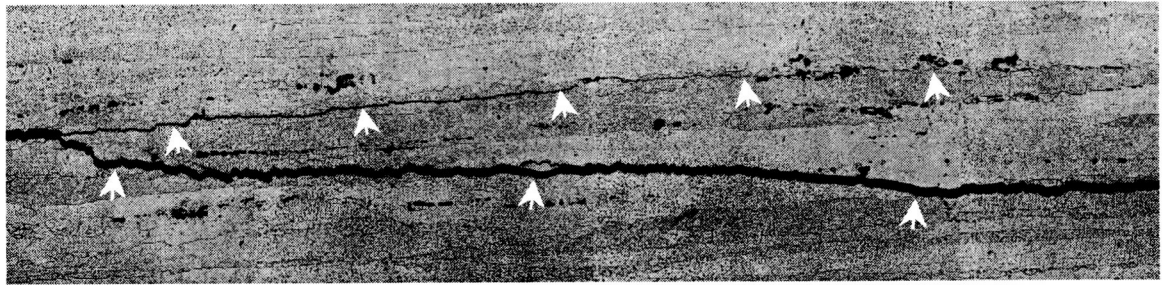
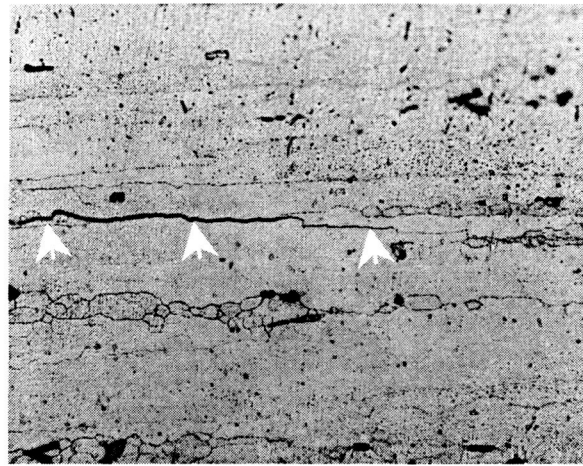
Optical microscopy was conducted on the specimens after fatigue crack growth testing. The side surface of the FCG specimen tested at a  $K_{max} = 6.6 \text{ MPa}\sqrt{\text{m}}$  was polished and etched prior to FCG testing so that the path of the fatigue crack could be tracked relative to the microstructure. Figure 22a shows that the path of both the main crack and crack branching (upper arrows) are intergranular. Figure 22b shows the fatigue crack-tip region and reveals that the crack-tip is located along a grain boundary. These result show that the crack paths of fatigue cracks grown in laboratory air are along grain boundaries and exhibit intergranular crack branching similar to the cracks found in the C5A forging shown in Figure 11. Detailed SEM examination of the intergranular fatigue crack surfaces at high magnification showed that the surface morphology was similar to crack surfaces removed from the tie box forging. Similar to the forging cracks, no evidence of striations was observed on the fatigue test crack surfaces.

Figure 22. Optical micrographs of an etched surface showing the intergranular fatigue crack growth crack path for FCG test conducted on C5A material. (a) The micrograph shows the main fatigue crack (lower arrows) and a secondary fatigue crack (upper arrows) that propagated along or near grain boundaries. (b) The micrograph shows the fatigue crack tip region (marked by arrows) and definitively shows that the fatigue propagated along grain boundaries.
